ENERGIABÖRZE

Project: Almásfüzitő, Hungary

(gas engine with 3 MW_e, 3 MW_{th} installed capacity)

Place of use: Hot water Pipeline system

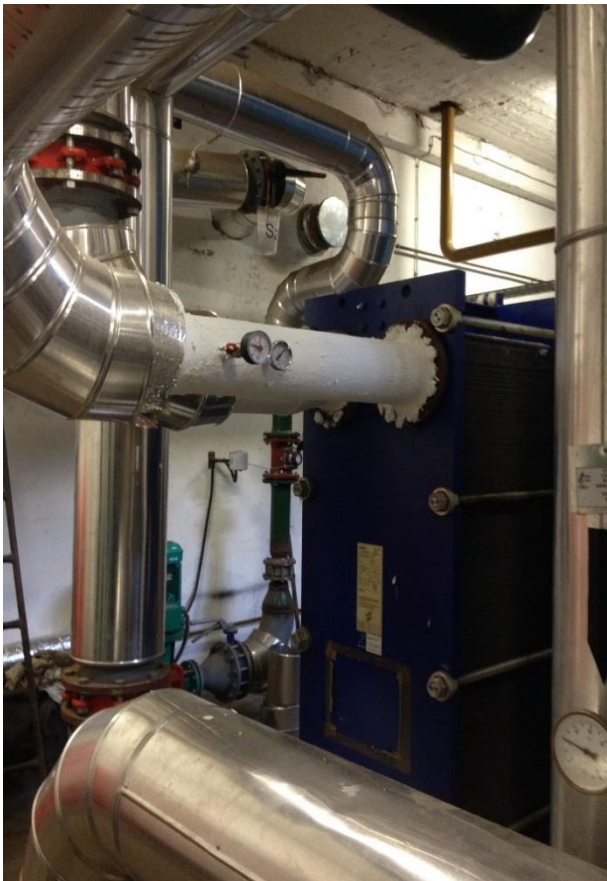
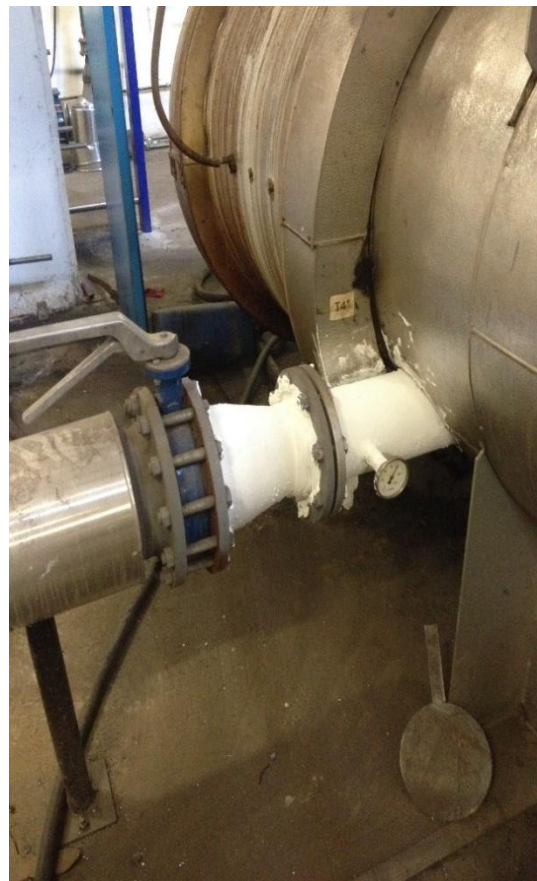
Some picture of the place of use:

The rockwool insulation and the tin coating are very complicated to use on a surface with many outstanding pipes, or measuring points. That's why we have used PSC. Painted it by a paintbrush 3 layers.

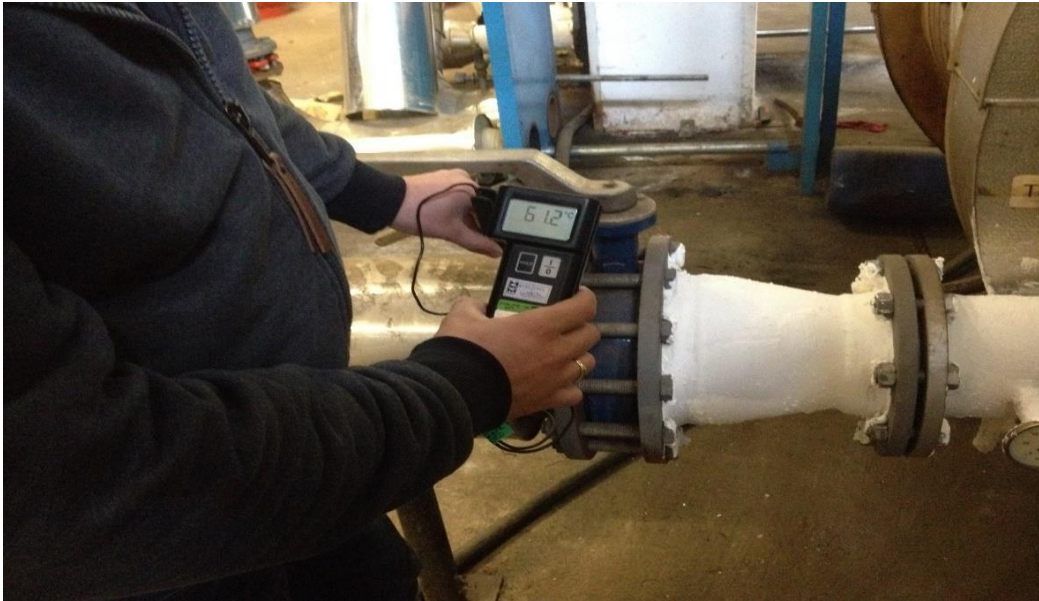
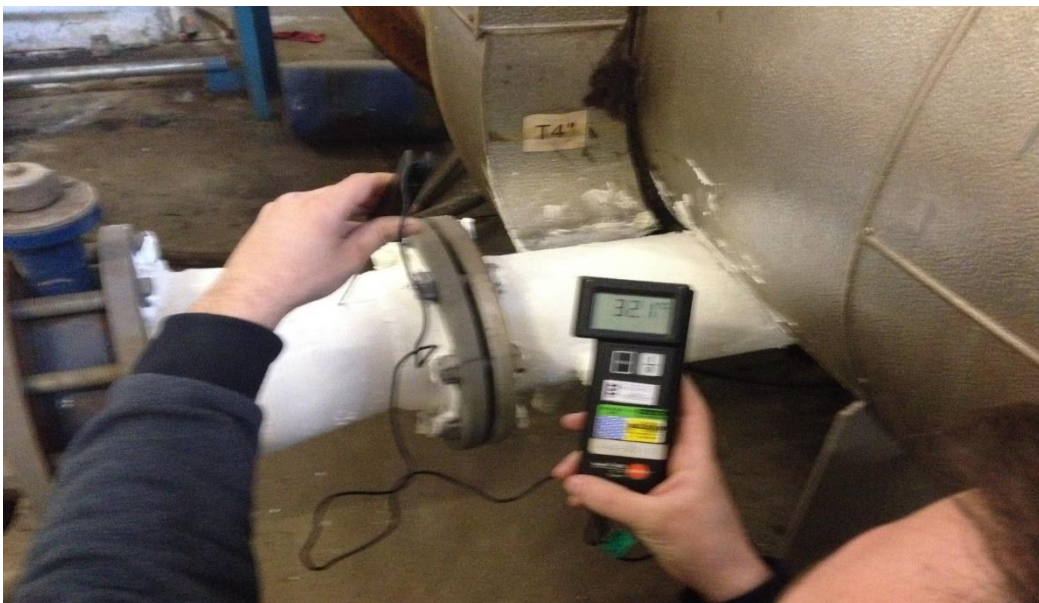
After the painting was dry, we checked the temperature of the surfaces, seen on pictures below:

Temperature was measured with a certified touch thermometer. During the measurement the hot water in the pipeline system was: 80°C.

Temperature of the surface of the pipeline system, without PSC insulation: 61,2 °C
Temperature of the surface of the pipeline system, with PSC insulation: 32,2 °C

As it is shown above, the temperature of the surface we used PSC reduced almost 30 °C. It is considered as a great result. Our experiences with the PSC were: easy to apply, it dries fast on hot surface, usable at any surface, heat insulation factor is high, water resistant, easy to correct if damaged.
